## MEMORANDUM

DATE: 14 October 2026  
FROM: Scott Finnis  
RE: **Isle of Palms** Beach Renourishment  
**Fill Material Quality Monitoring Update**

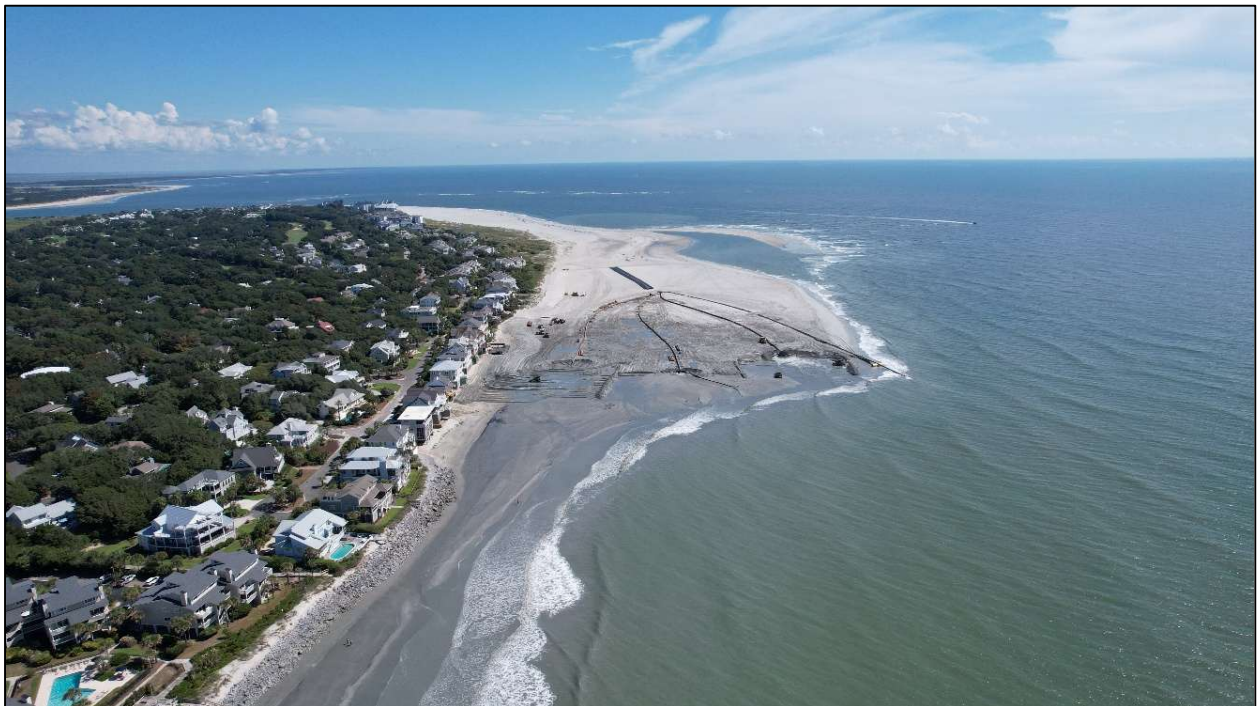
**FIGURE 1.** Reach 1 was completed on 30 August 2026 and mobilized to Reach 2 shortly after. At the time of writing this report Marinex is working in front of Grand Pavilion (*image collected 21 September 2026*).

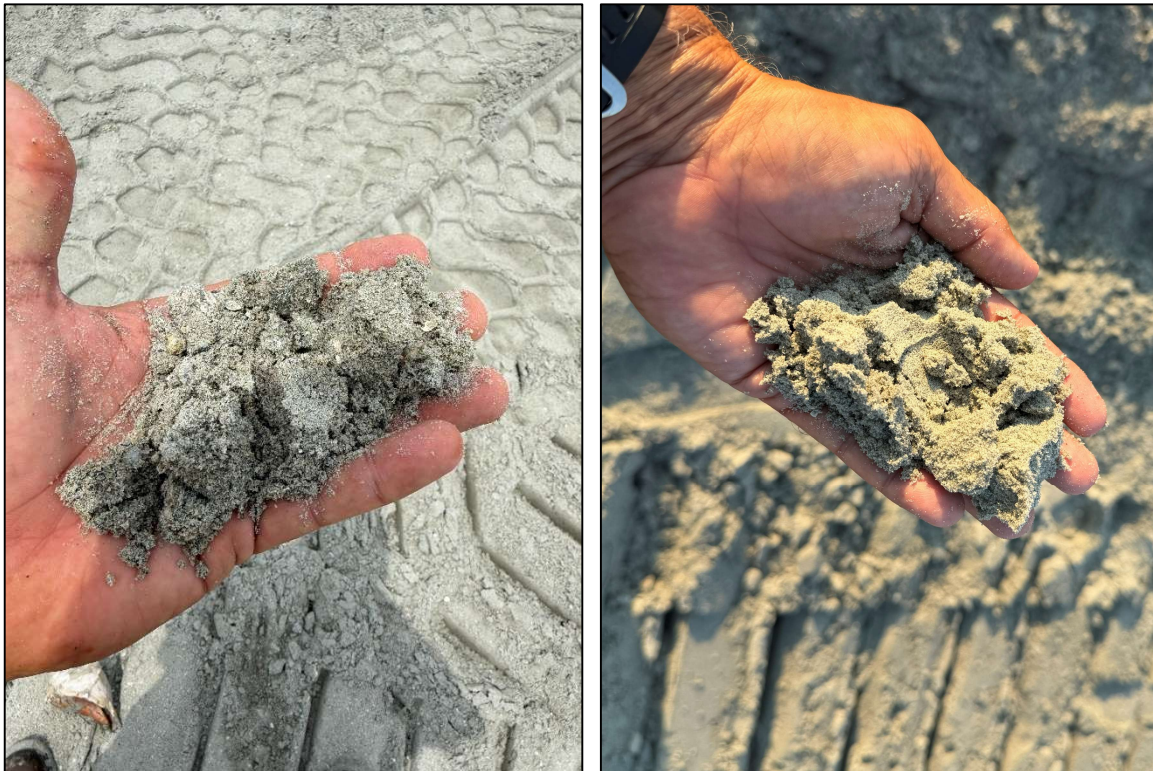
**FIGURE 2.** Material characteristics observed to date have represented a close match to the native beach sand at Isle of Palms. Fill material is light gray to light tan with minor fractions of shell hash and pea gravel. Samples collected along the upper portions of the profile tend to exhibit slightly higher shell content while sorting related to wave action along the lower portions of the profile tend to exhibit slightly lower shell content. Both images were taken in Reach 1.

Material color to date consists of light gray to light tan medium sand with shell hash and minor fractions of granule- or fine-sized grains (Fig 2). While freshly-dredged material is always darker than native beach sand – by virtue of it being harvested from the seafloor – it brightens quickly following exposure to sun and wave action. Comparing an aerial image collected on 15 August with one collected on 18 September demonstrates the extent of brightening in the berm’s surface color over a four-week period (Fig 3).
