## **Appendix**

- A. HHI beach width summary – page 19 2022 Monitoring Report
- B. Page 65 of 2024 IOP monitoring report
- C. HHI Executive Summary – 2022 Monitoring Report
- D. IOP Draft Executive Summary – 2026 Monitoring Report

## Town of Hilton Head Island, SC 2022 Annual Beach Monitoring Report

# Appendix D - Draft executive summary IOP 2026 Monitoring Report

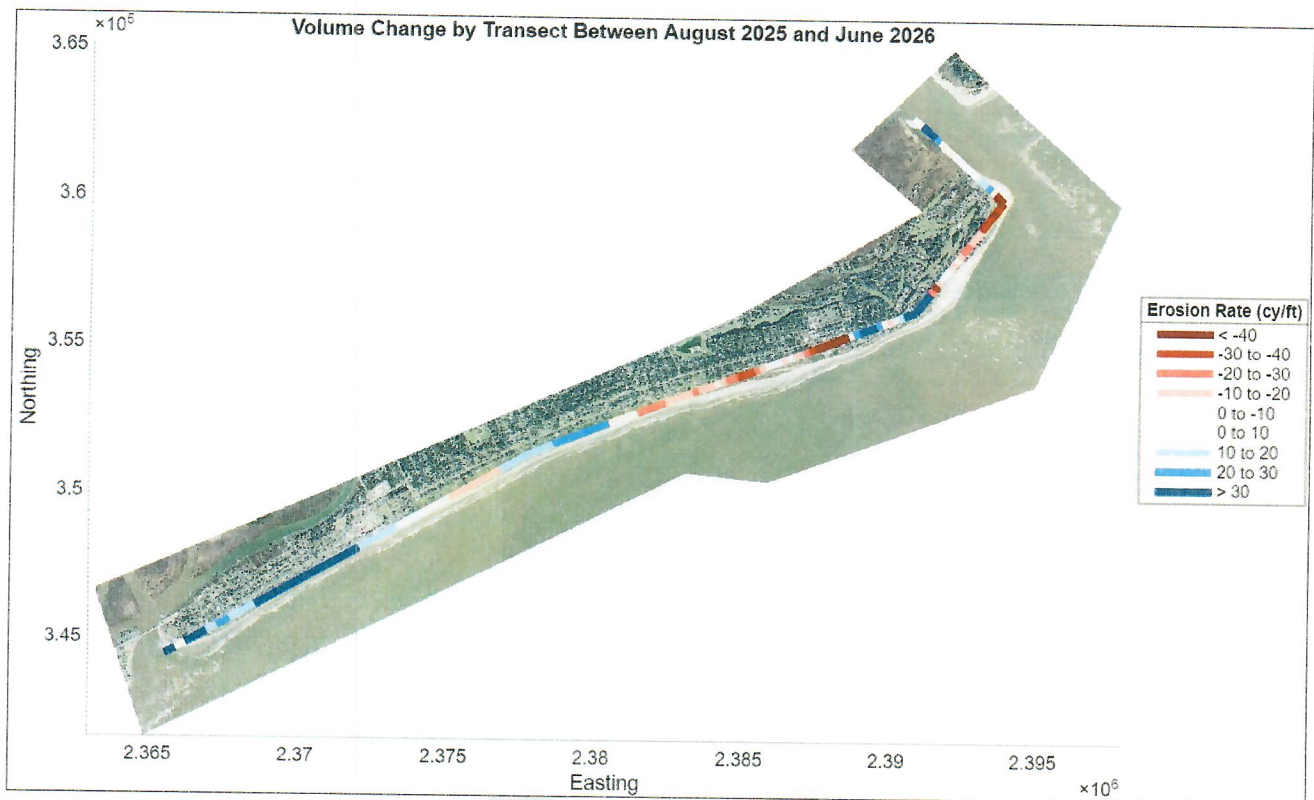
**FIGURE B.** Image showing the volume change by station for the year. Accretion (blue) is mostly seen in the south end of the island, where the USACE project and downdrift movement of sand have built up the beach. There are also pockets near the shoal attachment areas. There is erosion (Red) shown in some of the erosion hotspots in reaches 5 and 6.
